GRANGER LAKE

FINAL FOUNDATION REPORT

EMBANKMENT-OUTLET WORKS-SPILLWAY

VOLUME-1
AUGUST 1983

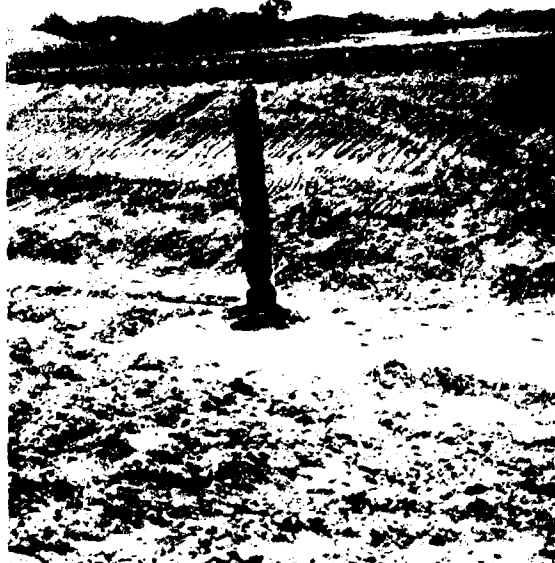
Figure 3. Cutoff trench, 1st contract: Looking toward right (south) abutment. Flooding on morning following figure 1. (Dike had been overtopped.)

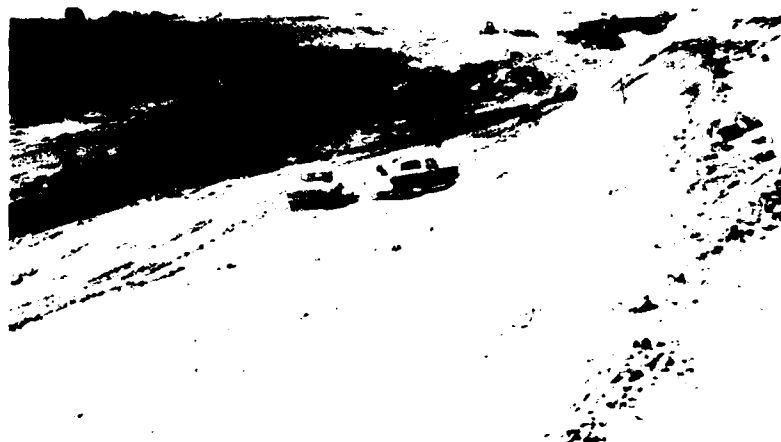
Figure 10. Cutoff trench, 3d contract: Looking north toward outlet tower and left abutment from about station 65+75, downstream. Balcones-type fault extends from station 67+65 (opposite side) to station 71+10 (this side).

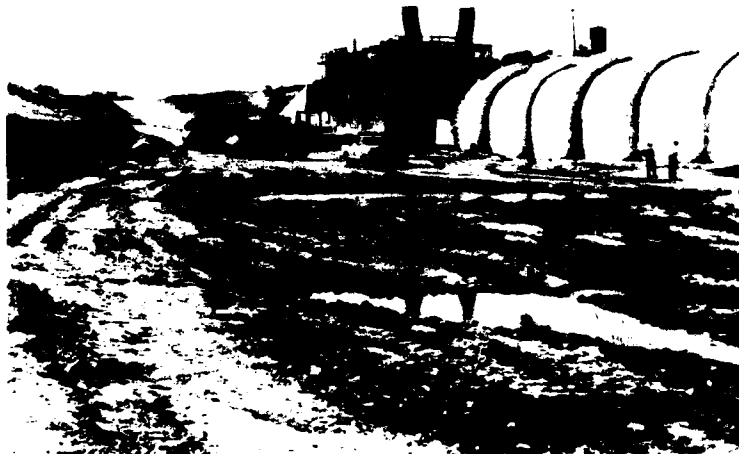
Figure 45. Outlet Works, 2nd contract: Looking upstream. Clean-up of shale "flat" for backfilling on right (south) side of conduit.

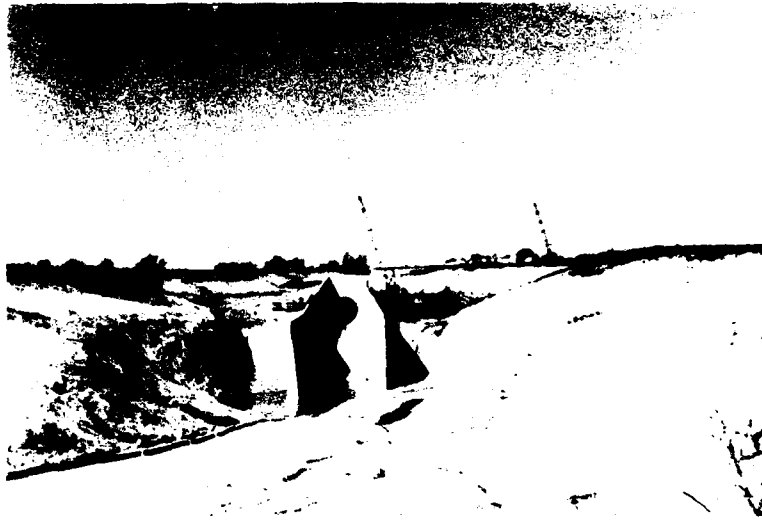
Figure 47. Outlet Works, 2nd contract: View of early stage of backfilling of outlet excavation, looking upstream along the centerline.

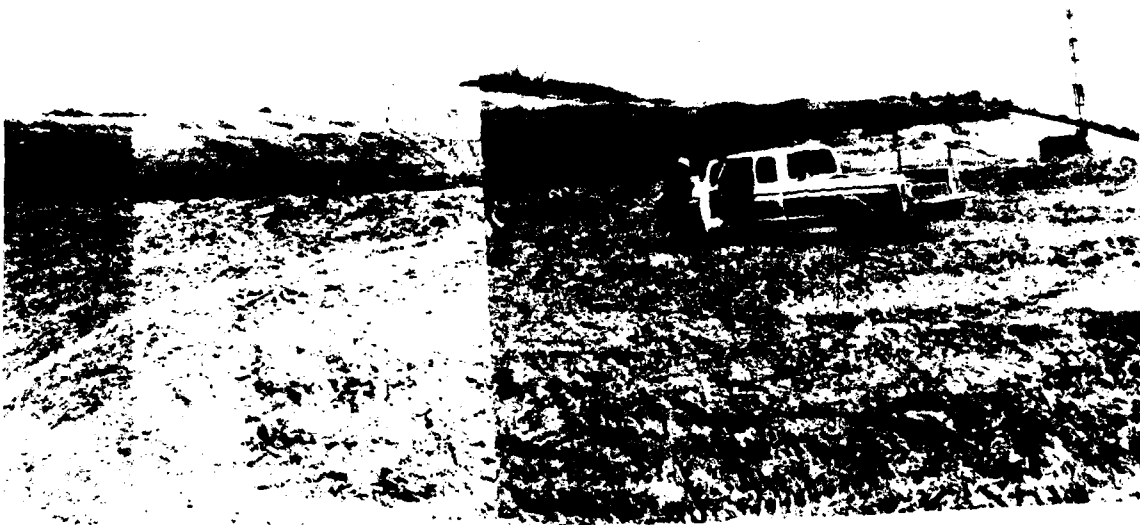
Figure 53. Spillway, 3d contract: Upper portion showing sectional view of cutoff trench back

ontract: Upper portion of left (north) sideslope
if cutoff trench backfill (from 1st contract).

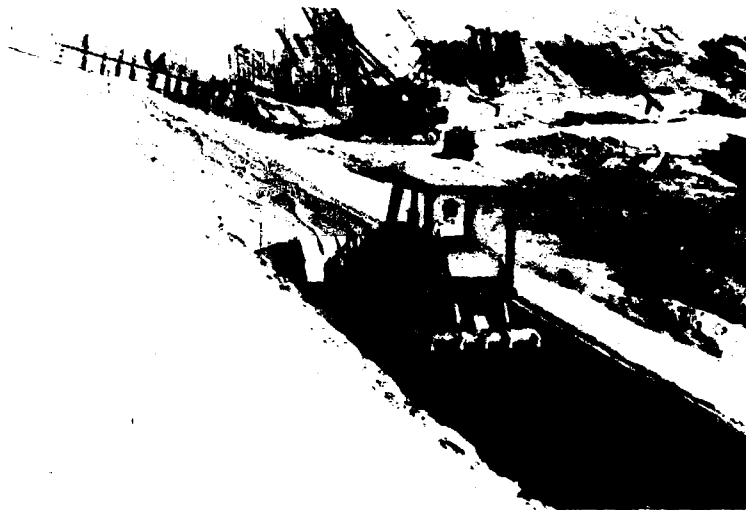
Initially, the cross drains in the chute were excavated after the drainage blanket had been placed. See figures 59, 60, and 61. Excavating the cross drains as a part of fine grading the chute slope was found to be more efficient, so separate excavation of drains was discontinued. See figures 62, 63, and 64. In contrast, none of the cross drains in the stilling basin were excavated as a part of finish grading the slab foundation. They were excavated after filter blanket sand had been placed, but before the work slab was constructed. The procedure for constructing keys in the chute was to excavate and place reinforcement and concrete through a breakout lane in the work slab. It was observed during inspection of keys, both in the chute slope and in the stilling basin, that the top 1 foot of the key sideslopes just below the drainage blanket was nearly always significantly rougher and more broken than was the remainder of the key sideslope below. This was observed both where desiccation of foundation shale was a problem and where it was not. The impression produced was that either the use of scraping tools to excavate the chute and stilling basin foundation caused a series of discontinuous breaks throughout the shale immediately below the scraped surface, or that the breakage observed was confined to the local effect of key excavation. If the former interpretation is correct, then designs for shale foundations should allow for somewhat diminished shear strength in approximately the first foot of the foundation.

Figure 59. Spillway, 3d contract: Excavating for a chute cross drain by initial method (see text).

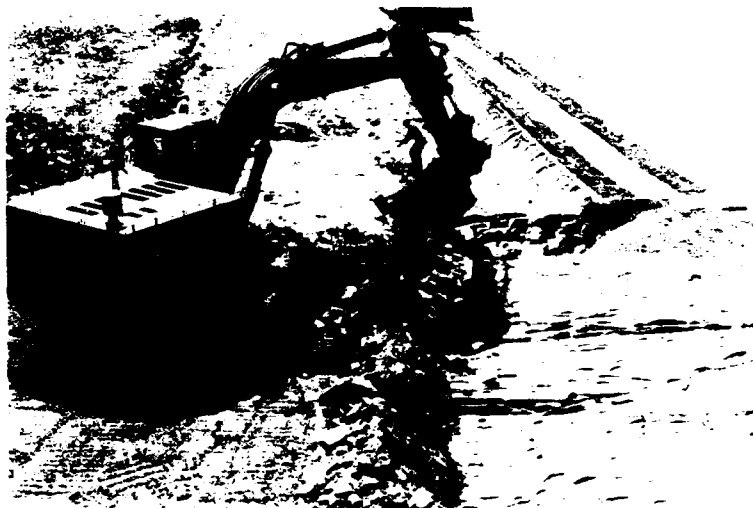
Figure 62. Spillway, 3d contract: Excavating a chute cross drain by final method (see text).

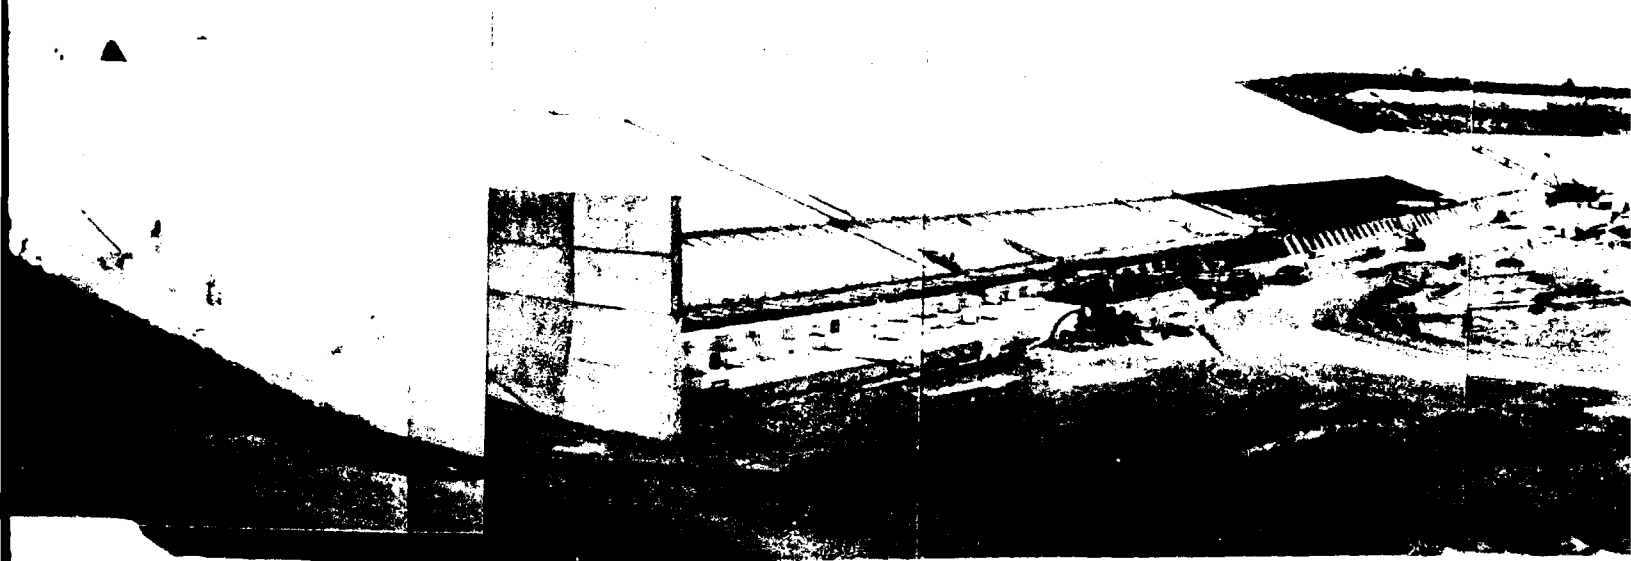
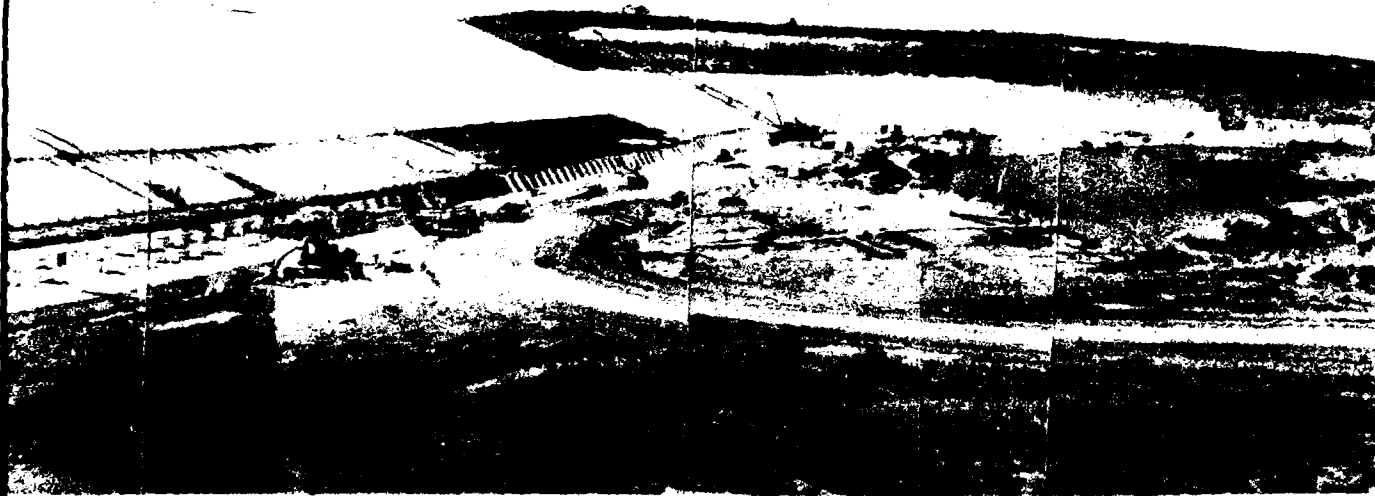
e 88. Spillway, 3d contract: View of the nearly finished spillway.
